# Managing Emergencies – Rudder Failure

*Round the world yachtsman Chris Tibbs considers how best to cope with a rudder failure at sea.*

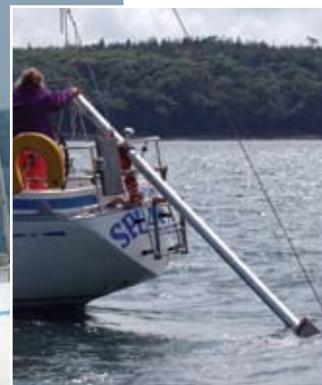
◀ Using a spinnaker pole and panel to rig a steering oar is a reliable method, though the force on the oar in big seas or strong winds can be great. ▼

A board was lashed to the spinnaker pole and passed through the pushpit. The size of the board was limited by

what could be comfortably passed through the pushpit. A topping lift to the outboard end of the pole, and an additional line to the backstay were added.

Used as a sweep the loads were high and the pole difficult to manage. By adding guys to the inboard end led to winches it became a little more manageable. Additional lines to the outboard end would probably have helped. There was a tendency for the blade to twist as the pole was moved from side to side; this problem could be overcome by lashing a bar across the inboard end. The lashing at the base of the backstay needed fine tuning as too tight and it is was difficult to move the pole, too loose and control was lost.

Verdict: Heavy and cumbersome and additional guys would have helped. The spinnaker pole dated from 1978 and is very heavy compared to modern poles that would probably have to have added support to avoid the risk of breakage. The crew of Heya in ARC 2001 attached the end of the spinnaker pole to the bathing platform; much of the load was taken from the pole. The steering worked in light winds but they had to remove sails or heave to when the wind strength increased.

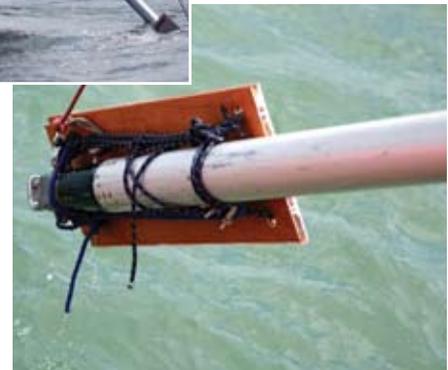
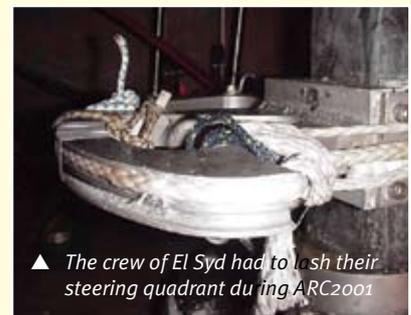
▲ The crew of El Syd had to lash their steering quadrant during ARC2001

Repairs to the steering mechanism may be possible and sailors on the whole are a very resourceful lot. The picture from El Syd shows lashings to hold the quadrant together. Self-steering may also act as a standby in an emergency when it is connected directly to the quadrant and some wind vane self-steering systems provides a small additional rudder.

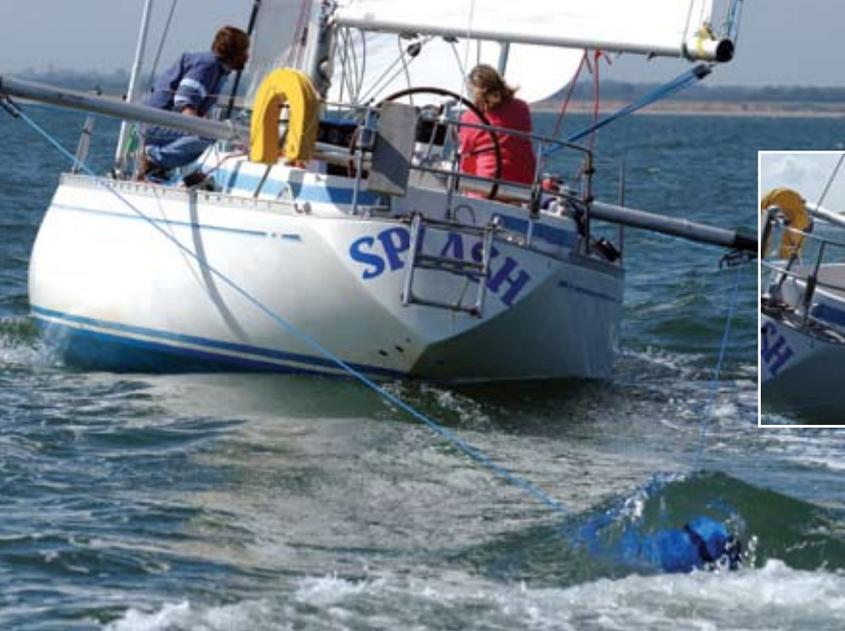
◀ Using the drag from a drogue to steer is easier in strong winds than using an oar

Verdict: Remarkably efficient. Drogue movements combined with sail trim made steering the boat reasonably easy. Not only was the boat controllable, but it felt controlled. Even with too much sail for the system, it was more a concern with the increased loads rather than one of keeping control.

A spinnaker pole was lashed, but not firmly enough as it happened, across the cockpit. With lines through blocks on either end a drogue was towed behind. The inboard ends of the lines were led to small winches.

Initially a small bucket was used as a drogue but as the wind had died the effectiveness was limited. This bucket was changed for a small kitbag with a 5kg weight, although as the bag filled with water this weight greatly increased.

Towed behind the boat the drogue was winched from side to side and the boat slowly turned. There was still the necessity to trim the sails so that the system was not overpowered, but with relatively little effort control was gained. The wind had dropped so against my better judgment the reefs were dropped and full sail raised.

The wind then increased to a force 4 and loads shot up dramatically. Larger winches had to be used and it became apparent that the pole was not securely lashed across the cockpit and slid from side to side. However the yacht was manoeuvrable and tacking proved relatively
